Consolidated Version – Fatalities - Injuries

FATALITY (FSI 20)

Very serious casualty: fire in crew accommodation and death of an oiler

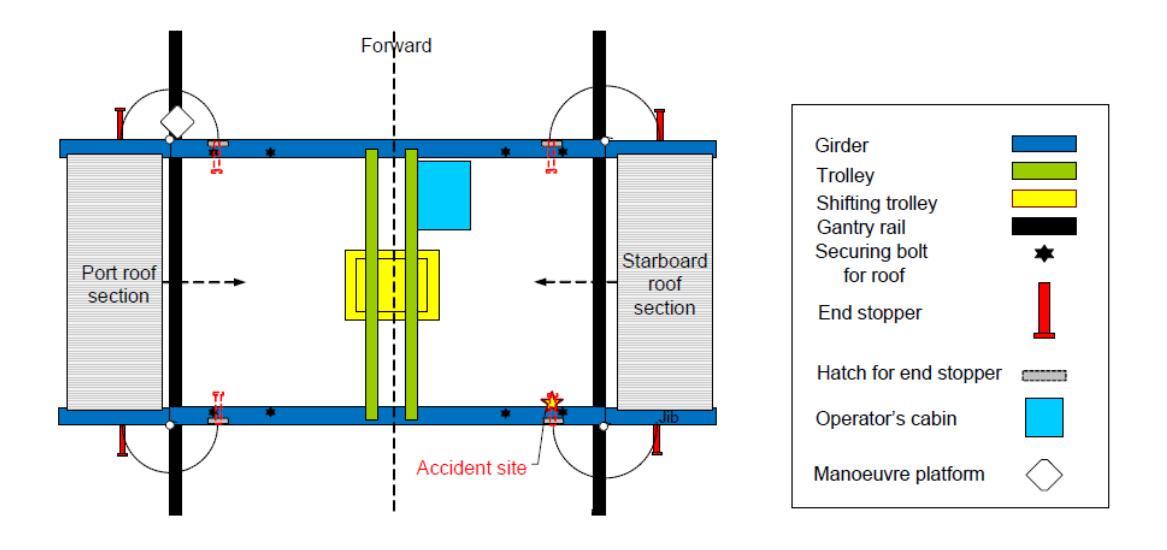
Figure 1: Simplified drawing of the gantry crane seen from above.

Swinging in of the jibs is done from a manoeuvring panel on a platform below the crane's forward port leg. A third crewmember went to the manoeuvring platform to swing in the jibs.

After confirmation that all crew were in a safe position, the four jibs were set in motion. Subsequently, and without notifying the other crew involved, two crew members on the girdens of the gantry crane identified that the end stopper hatches located in the protective walls needed to be open. The two crew then immediately went and opened the end stopper hatches. Following that, one crewmember was found struck and killed by the end stop of the starboard aft jib.

After having opened the hatch for the end stop, he may have given his attention to checking the chain to be attached to the T-shaped securing bolt in the aft corner of the starboard sliding roof section. This is based on where the boatswain was hit and the position in which he was found.
